## 4.0 Sewer System Evaluation Study

SEWER SYSTEM EVALUATION STUDY  
LOW LEVEL SEWERSHED STUDY AND PLAN

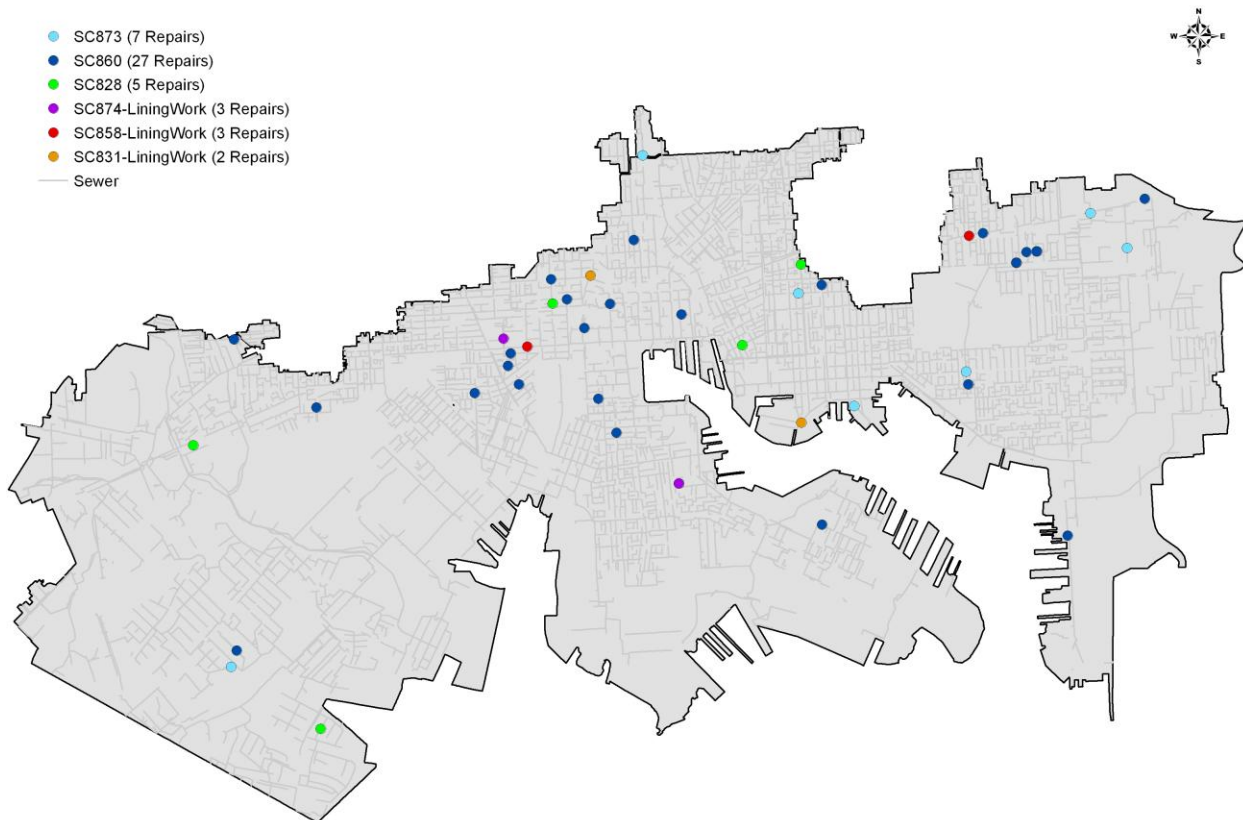
**Figure 4.7.1 - Sanitary Repairs performed in the Low Level Sewershed (January 2006 to March 2009)**

The resolution of the work was prioritized based on on-going repair work being performed within the City and the severity of the deficiency discovered (emergency or priority). As the City-wide evaluation survey continues, new deficiencies will be identified and reported to the City. To date, the City has completed cured-in-place (CIPP) lining of 8 locations and has made 39 point repairs within the Low Level sewershed. Figure 4.7.1 shows the spatial locations of these repairs by sanitary contract number.
